ANALYSIS OF A FLAMMABLE LIQUIDS FIRE LEADING TO A BACKDRAFT EXPLOSION

Robert Zalosh¹ and San-Ping Ho²

*Firexplo
Wellesley, MA USA*

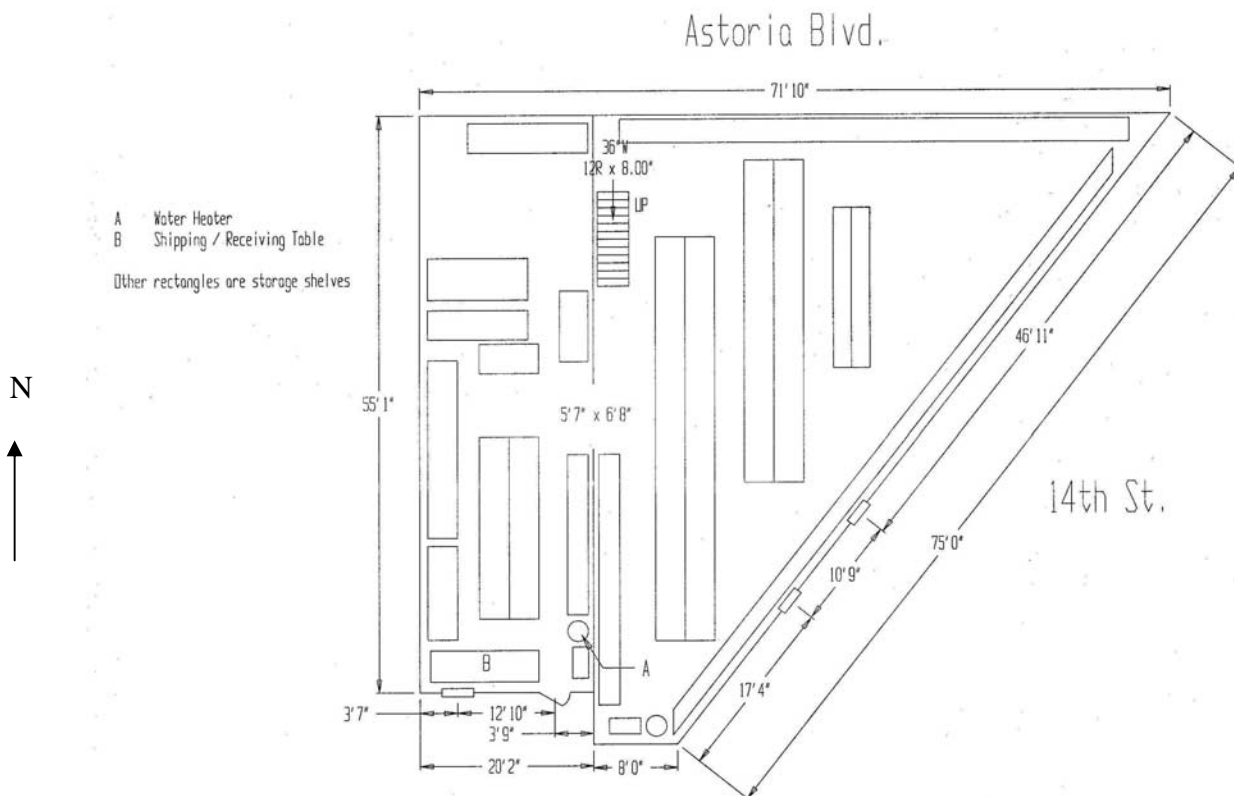
Figure 2. Basement layout and dimensions.

Figure 2 shows a plan view of the basement, which is actually composed of two buildings with a common wall. The 12-20 (West) side of the basement is a 20-ft wide by 55-ft (6.1m x 17m) long rectangle. The 12-22 (East) side of the basement is a trapezoid with widths of 51-ft and 8-ft (15.5m and 2.4m), and a length of 60-ft (18m). The 0.81m wide opening between the two sides of the basement was protected with a horizontal sliding fire door, but wooden dowels in the door floor-track and a plywood ramp over it prevented the door from closing. The basement height to the sheet rocked (gypsum board) ceiling is 1.9m. The entrance to the alley was on 14th St.

vertical bars about $\frac{3}{4}$ " (19 mm) thick. There are also two horizontal steel bars across the door, which is intended to be opened from inside. The locked exterior wood door has sheet metal facing on both sides. A gas-fired hot water heater is situated at location A in Figure 2, with the center of the heater approximately 9 ft (2.7 m) in from the rear door. A gas-fired boiler is situated between the hot water heater and the rear door.

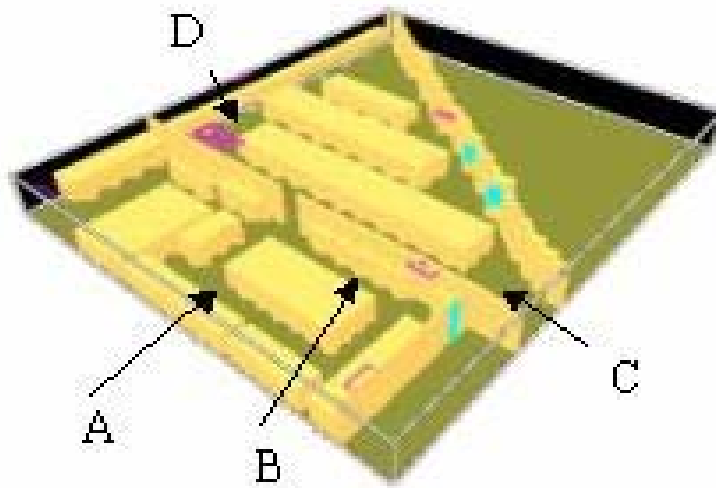
Figure 3 FDS representation of basement and contents.

The geometrical representation of the hardware store basement is shown in Figure 3. The grid cell size used was 0.1m by 0.1m by 0.1m. Besides the overall dimensions and layout of the 12-20 (West) side and 12-22 (East) side of the basement, the FDS input also included representations of shelf storage in both rooms. FDS “thermocouples” were placed at the locations designated as A, B, C, and D to obtain vertical profiles of gas temperatures and oxygen concentrations. Small ventilation openings were assumed as follows:

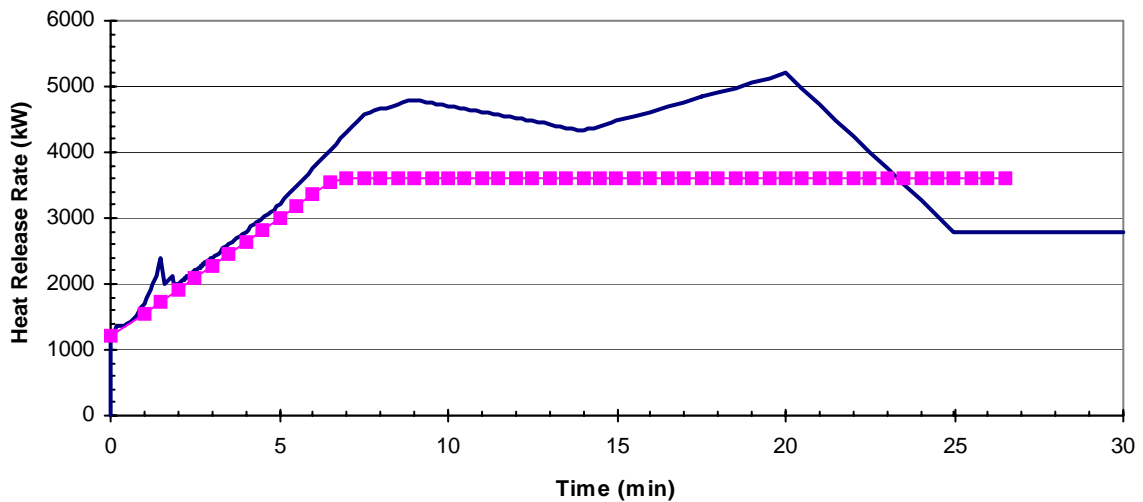
Figure 4 Heat release rate history used in FDS simulation.

The total heat release rate is the sum of the contributions from the six commodities listed in Table 2. It is shown as a function of time in Figure 4. The actual heat release rate history used in the FDS simulations is the simpler curve shown in Figure 4 in which the heat release rate grows linearly from 1200 kW at t=0 to 3600 kW at 7 minutes after ignition, and remains at 3600 kW for the duration of the fire. The FDS fire is located in the southern half of the west (12-20) basement room.

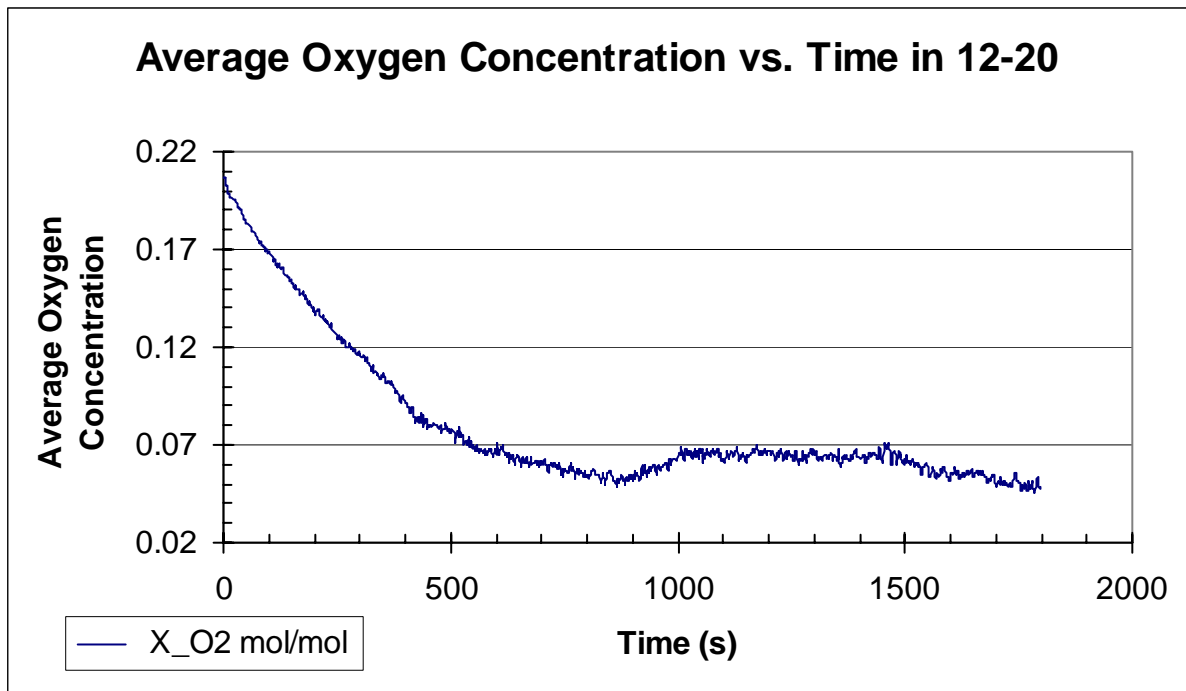
Figure 5. Average Oxygen Concentration versus Time in West Basement Room 12-20.

The calculated average oxygen concentrations in the west (12-20) and east (12-22) sides of the basement are shown in Figures 5 and 6, respectively. Results indicate that the 12-20 room-average oxygen volumetric concentration decreased from 21% to about 5% in the first 13 minutes of the fire, and remained between 5% and 7% until the time of the explosion. Oxygen concentrations in the hot gas layer under the ceiling were significantly less than 5% after the first 6 minutes of the fire. The 12-22 room-average oxygen concentration decreased to about 15%, and decreased further to about 9% at the time of the explosion. Details of both the oxygen concentration and temperature distributions are given in the 2002 report submitted to the NYFD [6].

Oxygen concentrations presented in Figures 5 and 6 were well below 12 volume % at 1800 seconds after ignition in both basement rooms. Fuel vapor concentrations from the vaporizing flammable liquids and incomplete combustion were not explicitly calculated, but a rough estimate of the amount of liquid needed to reach a fuel vapor mass fraction of 0.15 in both rooms can be obtained from the room volumes. If we assume that at the point in the fire that the liquid is released, the oxygen concentration is too small to support combustion, and that the vent areas are so small that most of the vaporized liquid remains in the room, the results for a representative liquid, MEK, indicate that only 18 gallons (68 l) are needed in the west (12-20) basement room, and 36 gallons (136 l) are needed in the east (12-22) room. Since there were approximately 24 gallons of MEK alone stored on the 12-20 side of the basement, and another 200 gallons of other flammable liquids, there

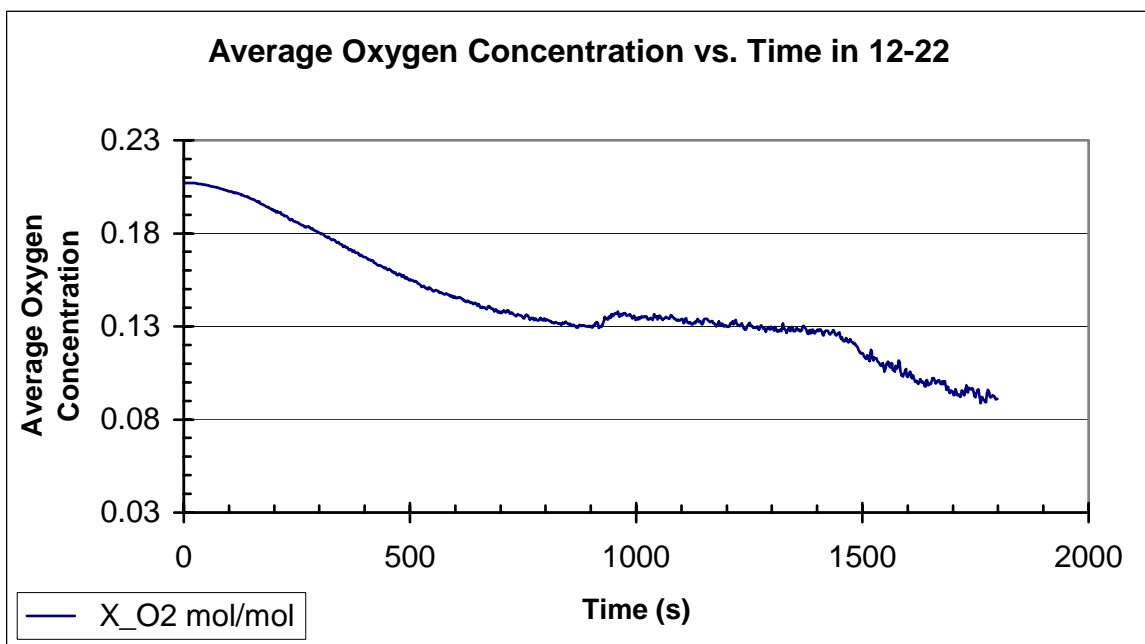
Figure 6. Average Oxygen Concentration versus Time in East Basement Room 12-22

The primary reason for the low oxygen concentration on the 12-22 side of the basement is the open fire door separating 12-22 from 12-20. The open door allowed air to flow into 12-20 under the hot combustion products that were flowing out of 12-20. When NIST used FDS to simulate steady-state fires with heat release rates of 500 to 2000 kW in the 12-20 side of the basement, they found that the fire door fusible link should have fused within 380 s of ignition and would have actuated door closer had it not been blocked open [7]. The NIST simulation of the resulting 2000 kW fire in an isolated 12-20 basement room indicated that the oxygen in 12-20 would have been consumed within 380 s.
